## Project Note

Subject: Observations made by Tetra Tech personnel during a March 2006 reconnaissance of the Smokey Mountain Smelters facility in Knoxville, Tennessee

### PROJECT NOTE SUMMARY

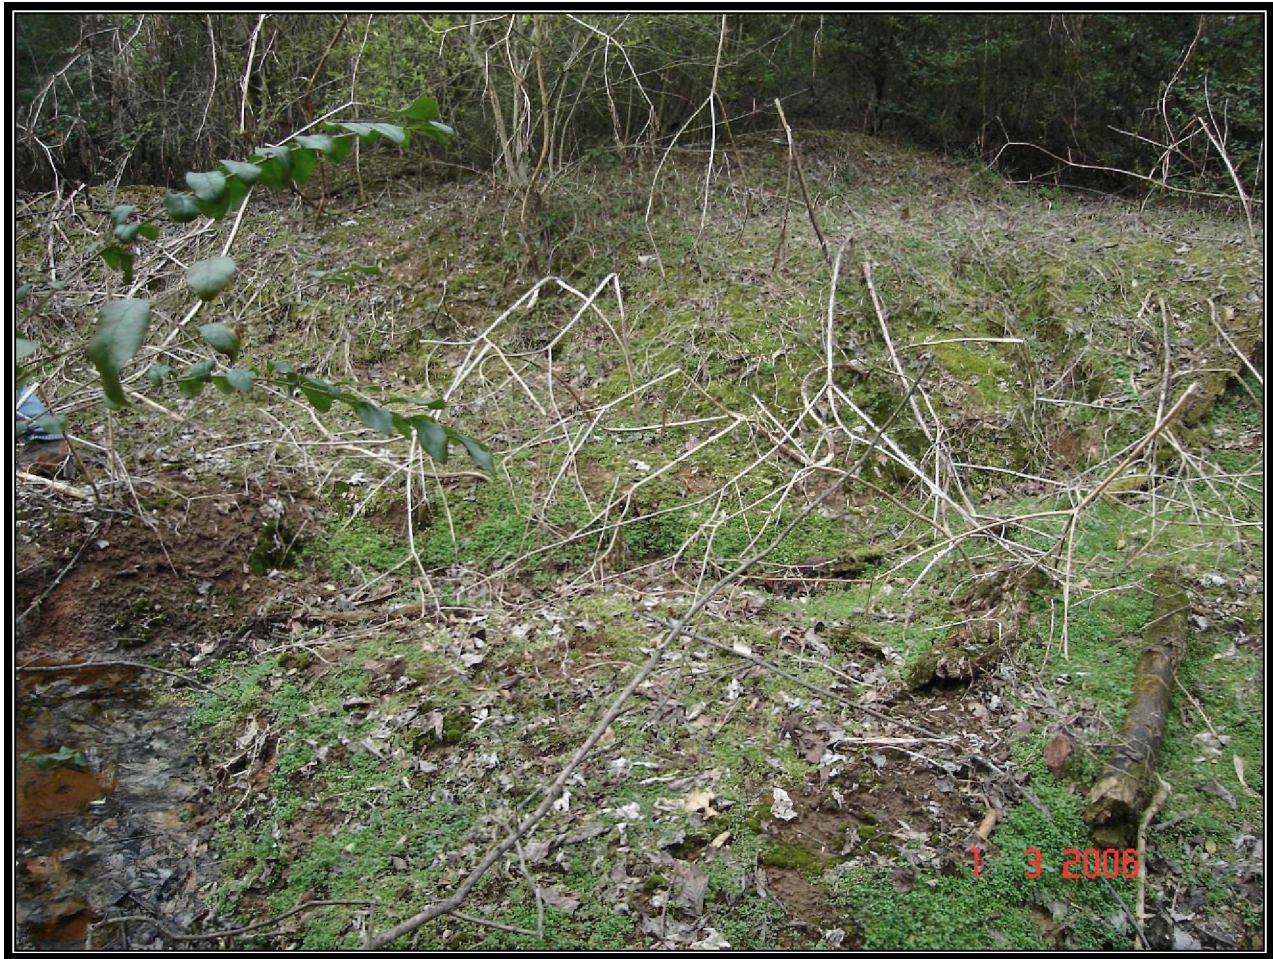
**OFFICIAL PHOTOGRAPH No. 17**  
**U.S. ENVIRONMENTAL PROTECTION AGENCY**

<b>TDD Number:</b>	TTEMI-05-003-0001	<b>Location:</b>	Smokey Mountain Smelters
<b>Orientation:</b>	East	<b>Date:</b>	March 1, 2006
<b>Photographer:</b>	Sandra Harrigan, Tetra Tech	<b>Witness:</b>	Loften Carr, EPA
<b>Subject:</b>	On-site unnamed perennial tributary of the East Branch of Flenniken Branch, just downstream of the leachate seeps. Moss can be seen on the ground in the upland areas along the stream.

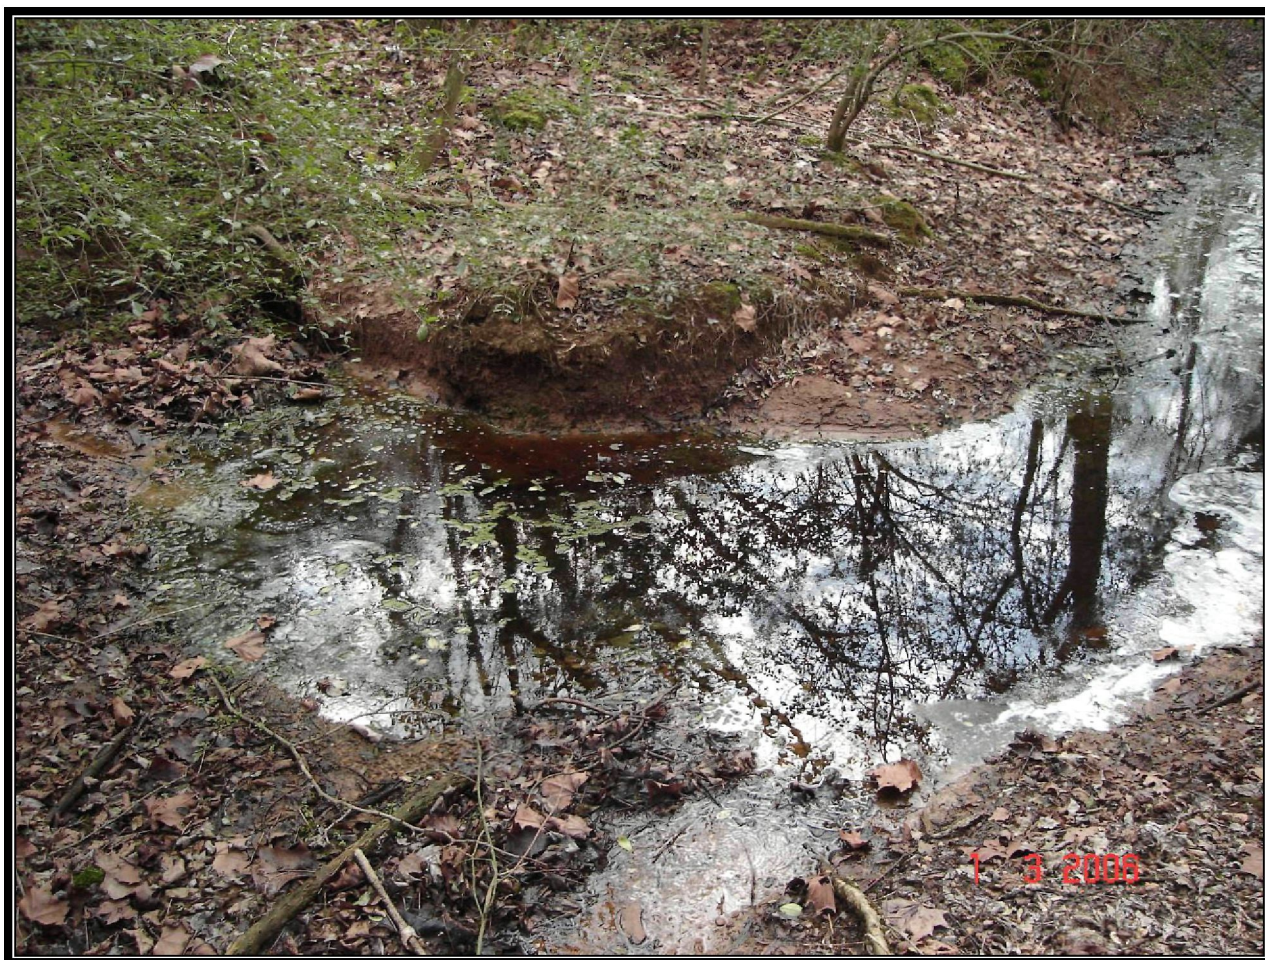
**OFFICIAL PHOTOGRAPH No. 18**  
**U.S. ENVIRONMENTAL PROTECTION AGENCY**

- White foam was present on the surface of the water where the seeps joined the on-site unnamed perennial tributary of the East Branch of Flenniken Branch. Foam was also present on the surface of the water at the confluence of the on-site unnamed perennial tributary and the East Branch of Flenniken Branch.

<b>TDD Number:</b>	TTEMI-05-003-0001	<b>Location:</b>	Smokey Mountain Smelters
<b>Orientation:</b>	South	<b>Date:</b>	March 1, 2006
<b>Photographer:</b>	Sandra Harrigan, Tetra Tech	<b>Witness:</b>	Loften Carr, EPA
<b>Subject:</b>	Confluence of the on-site unnamed perennial tributary with the East Branch of Flenniken Branch. White foam is present on the surface of the water.

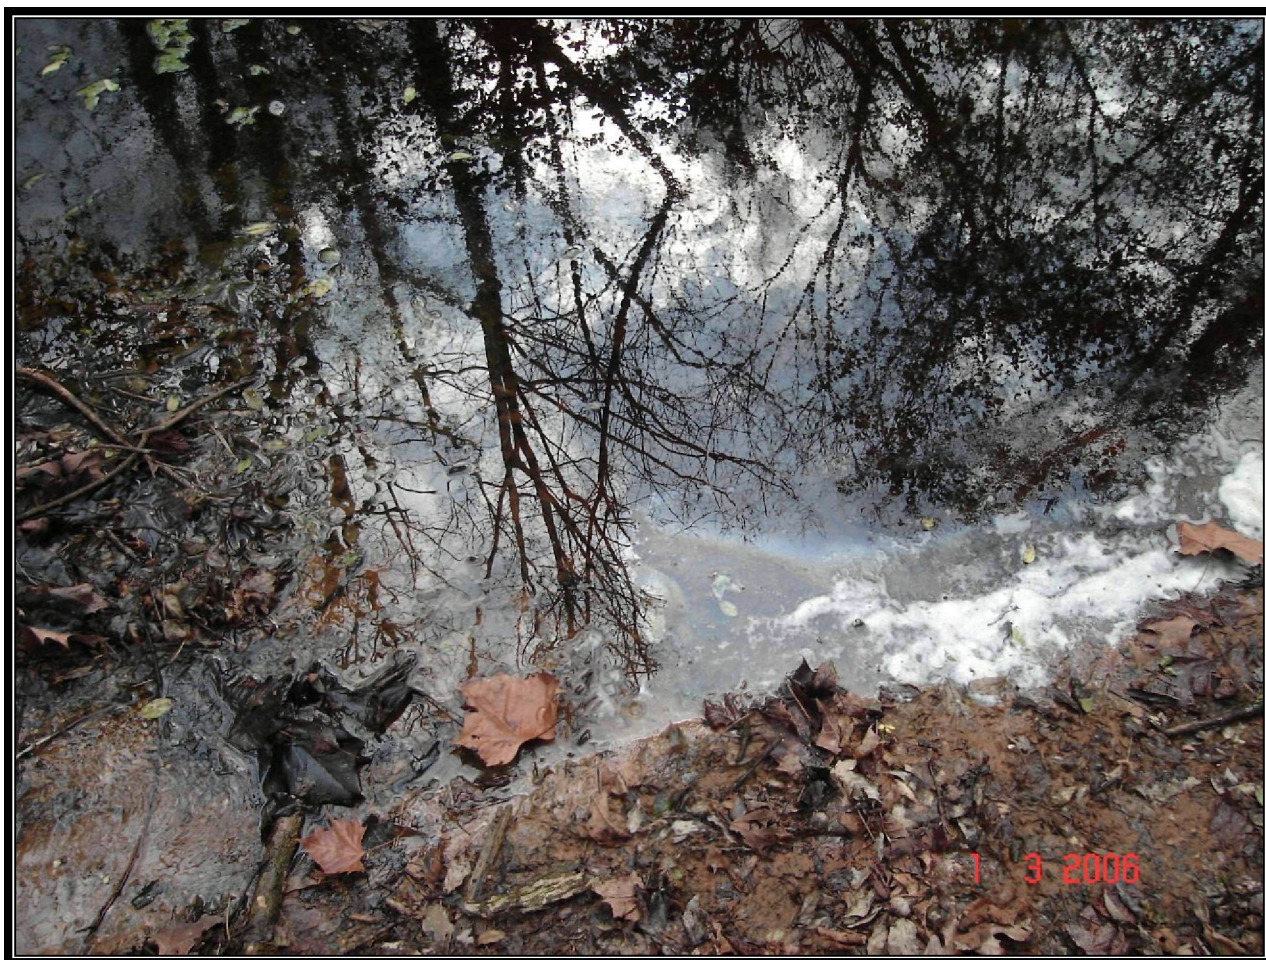
**OFFICIAL PHOTOGRAPH No. 19**  
**U.S. ENVIRONMENTAL PROTECTION AGENCY**

**TDD Number:** TTEMI-05-003-0001      **Location:** Smokey Mountain Smelters  
**Orientation:** East      **Date:** March 1, 2006  
**Photographer:** Sandra Harrigan, Tetra Tech      **Witness:** Lofton Carr, EPA  
**Subject:** East Branch of Flenniken Branch, downstream of the SMS facility.

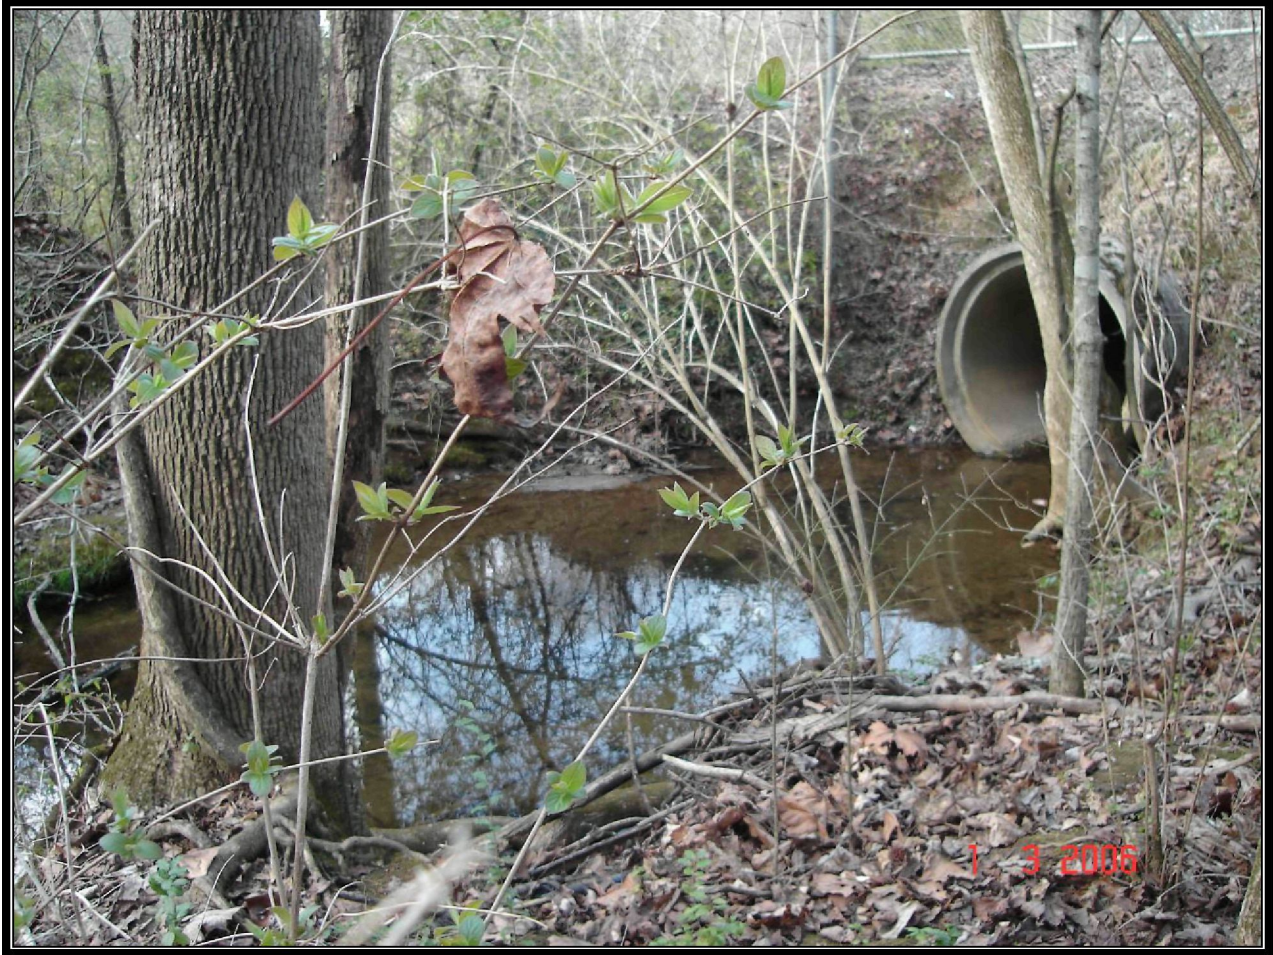
**OFFICIAL PHOTOGRAPH No. 20**  
**U.S. ENVIRONMENTAL PROTECTION AGENCY**

- The East Branch of Flenniken Branch was observed in the vicinity of the location marked as BM867 on the U.S. Geologic Survey topographic map, just upstream of Flenniken Branch (see Reference 3). The stream goes through a culvert under a street in this area. Small fish were observed in the East Branch of Flenniken Branch on the downstream side of the street. Also, fishing poles were observed along the bank of the stream in this area. However, actual fishing by local residents was not observed.

**Subject:** Flenniken Branch, downstream of the SMS facility. The stream goes through a culvert. The water is more shallow on the north end of the culvert and is about 2 feet deep on the southern end. Small fish were observed in Flenniken Branch on the southern end of the culvert. This location is near Benchmark 867 on a U.S. Geological Survey map (see Reference 3).
